COPPER readout

S. Yamada (KEK, IPNS)

READOUT SUBSYSTEM IN BELLE II DAQ

1. Data corruption on HSLB/COPPER

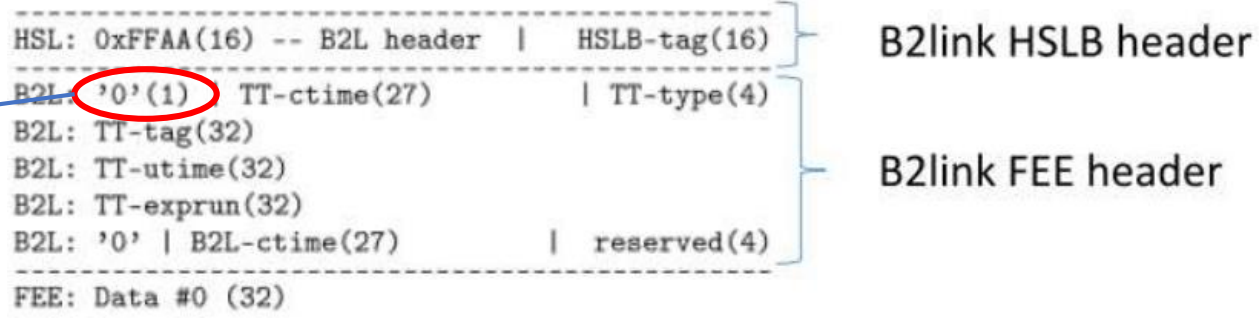
Workaround to avoid the first "ff00"

The 1st byte is supposed to never be "ff".

➤ Just ignore if the 1st byte of an event from FIFO_rx is 'ff' .

After the workaround implemented on Jun.16, this type of "ff00ff00" error has not been observed so far.

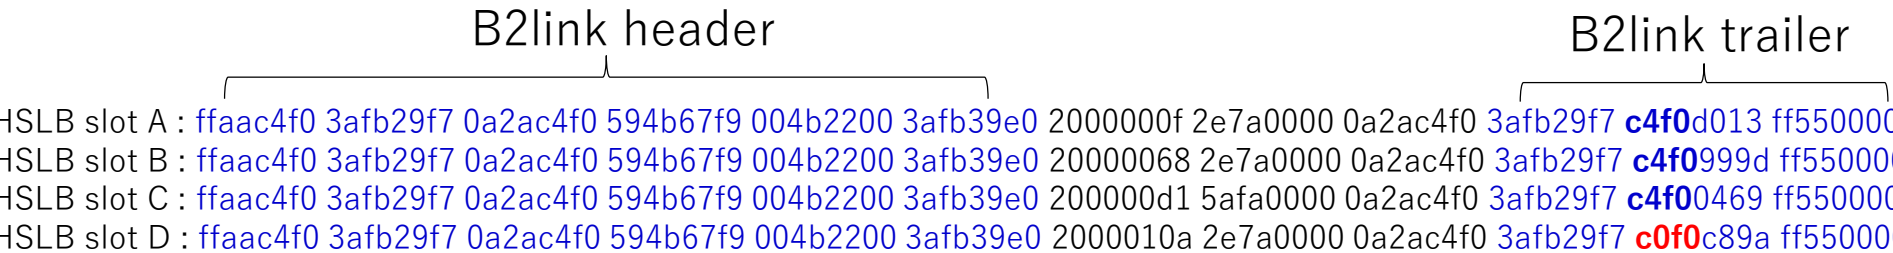
ii. Also observed in CDC suppressed data of high-rate test

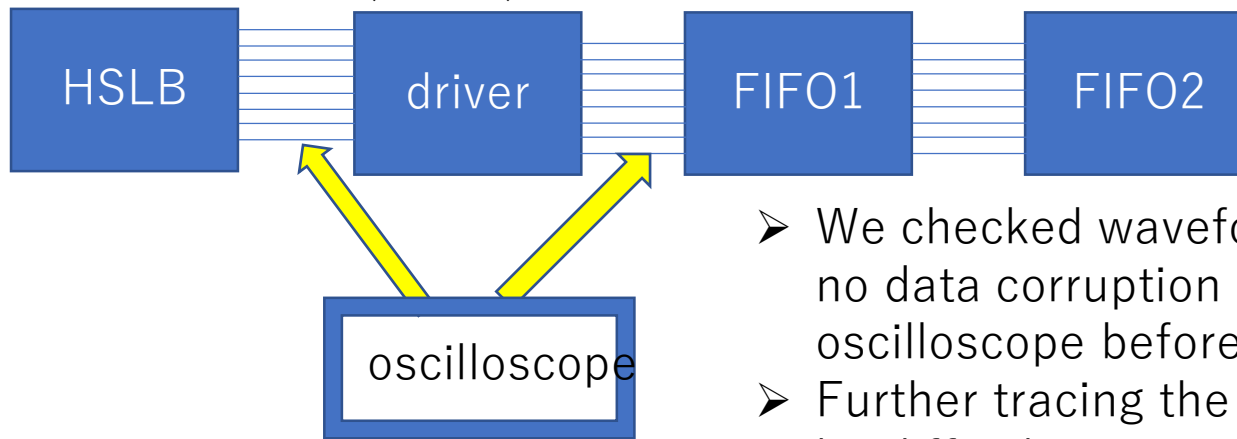
FF lines(0...31)

iv. Data are corrupted before FIFO?

- We checked waveform by oscilloscope, no data corruption was detected by an oscilloscope before the 1st FIFO.
- Further tracing the signal line seems to be difficult.

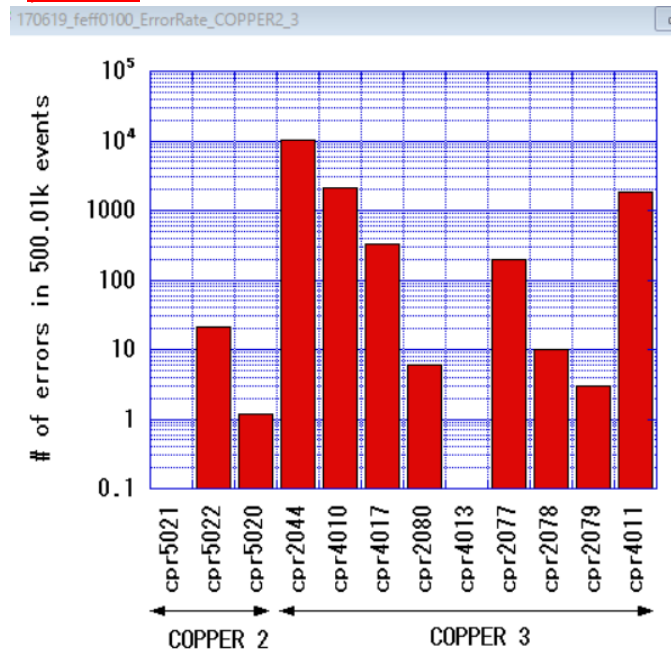
of CRC errors in feffffff 01000000 test pattern

v. Error-rate dependence on boards

slot A	slot B	slot C	slot D	
cpr3001	0	0	0	0	2
cpr3002	0	0	0	0	0
cpr3003	63	6	15	1015	
cpr3004	1	12	4	524	
cpr3005	18	13	19	71	
cpr3006	176	20	73	2190	
cpr3007	2	0	3	23	
cpr3008	50	37	269	1419	
cpr3009	4	3	5	207	
cpr3010	0	0	0	1	
cpr3011	120	10	15	142	
cpr3012	35	2	8	32	
cpr3013	7	0	1	0	
cpr3014	2	1	4	79	
cpr3015	210	15	143	1702	
cpr3016	10	1	2	33

Replacing some problematic boards for TOP DAQ would be worth trying.

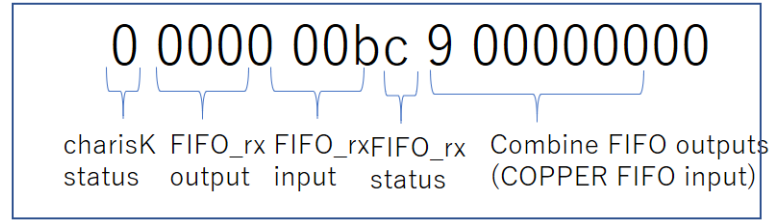
FF data output and write enable

write_en = false
write_en = true

- So far, even when write_en = false, the output from HSLB (FF data) has some value.
- I changed the firmware to keep FF_data zero while write_en = false.

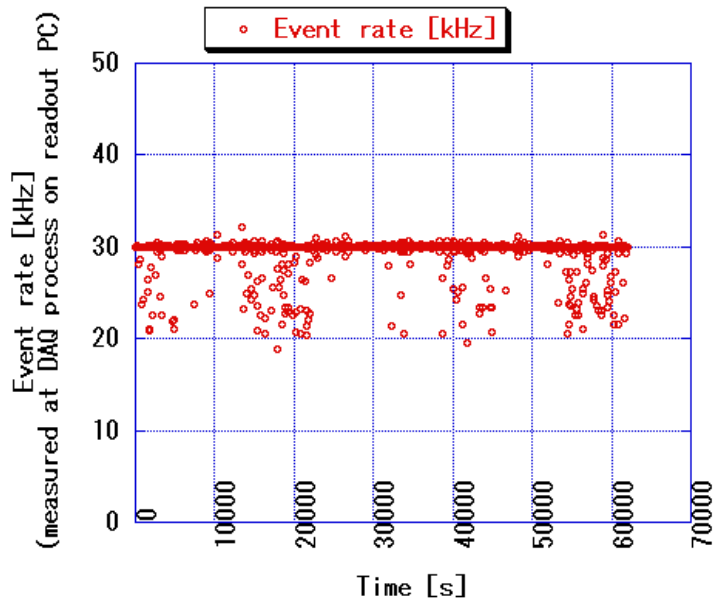
2-1. Stress test for ECL : input pseudo-Poisson 30kHz

- Throughput : about 33MB/s/COPPER (the expected event size from MC)
 - Event size was adjusted by HIT threshold of ECL FEE
 - Total throughput for Barrel ECL : 600 MB/s
- Constant 30kHz trigger -> efficiency = 99.2%
- Pseudo-Poisson 30kHz trigger -> efficiency = 98.2 %
 - The deadtime comes from trigger limitation (5trigger in 26us due to SVD FEE). -> 5trigger/26us from SVD is not correct. (My misunderstanding)

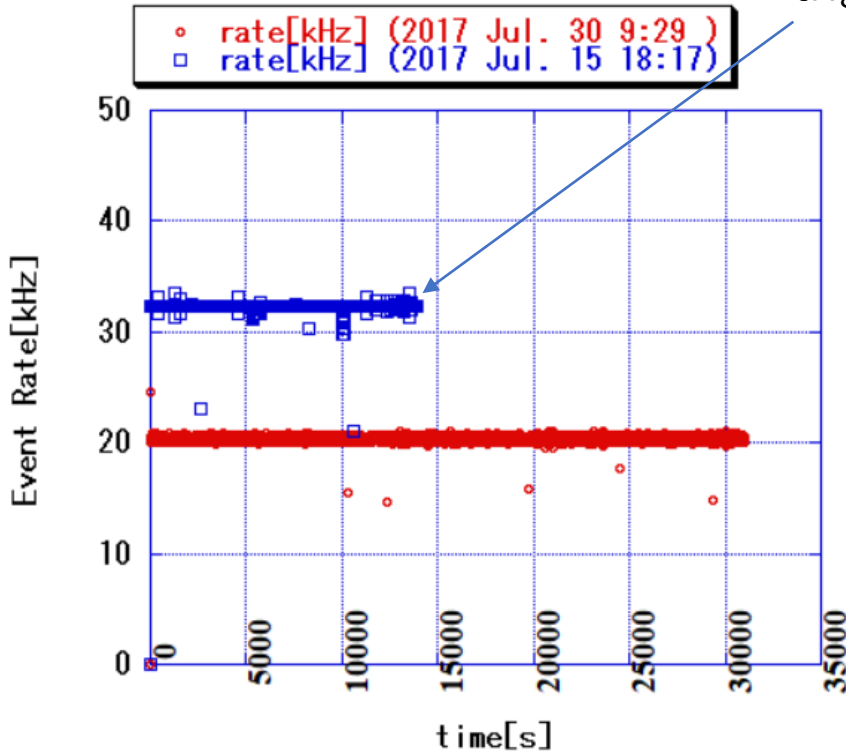
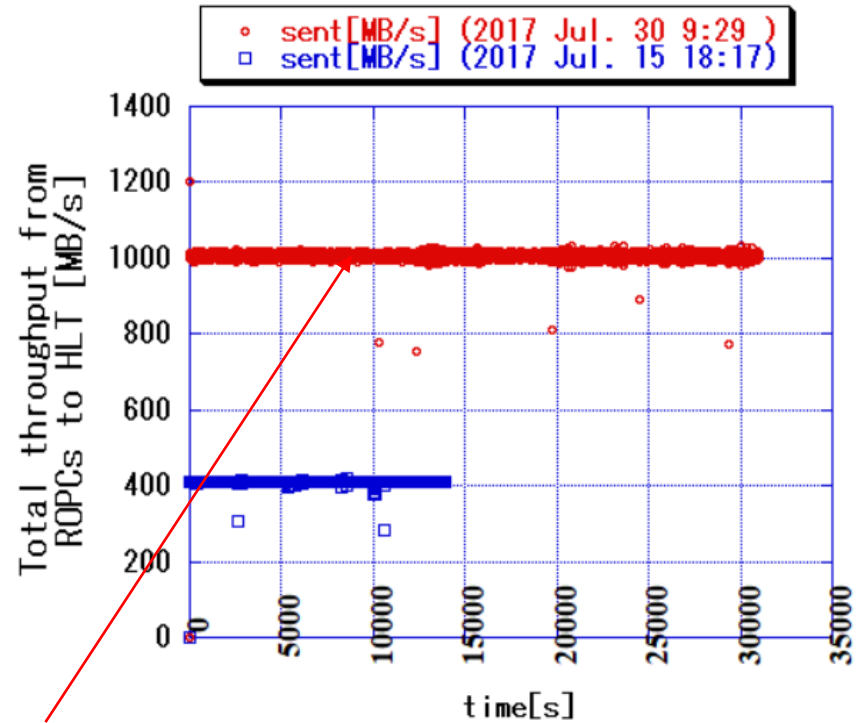
- Max. # of triggers from FTSW : 12trg in 350 us (FTSW default value)
 - 32kHz is the max. rate due to the trigger hold-off.

Limited by the trigger hold-off

Probably limited by 10GbE line rate between readout PCs and HLT

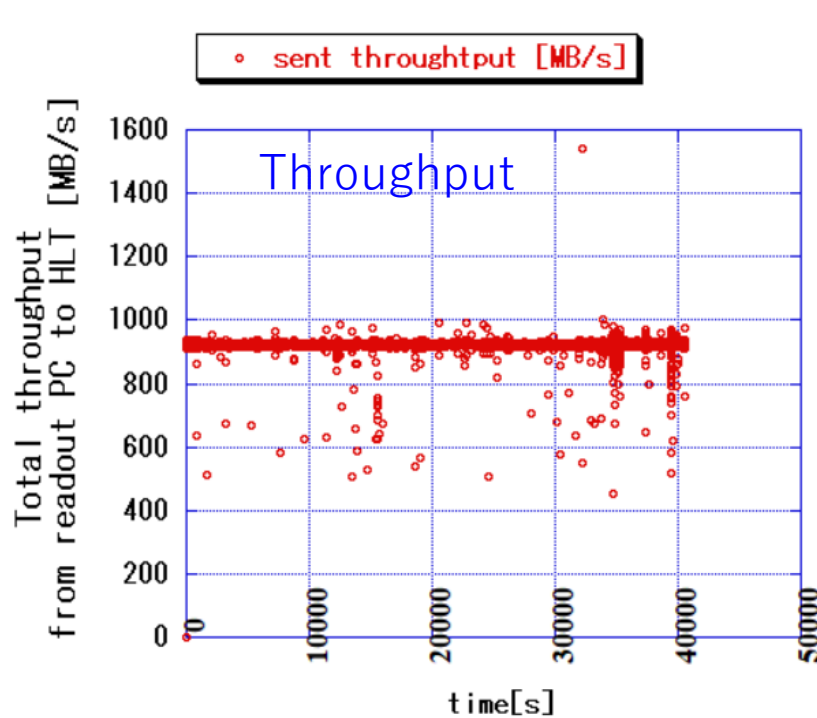
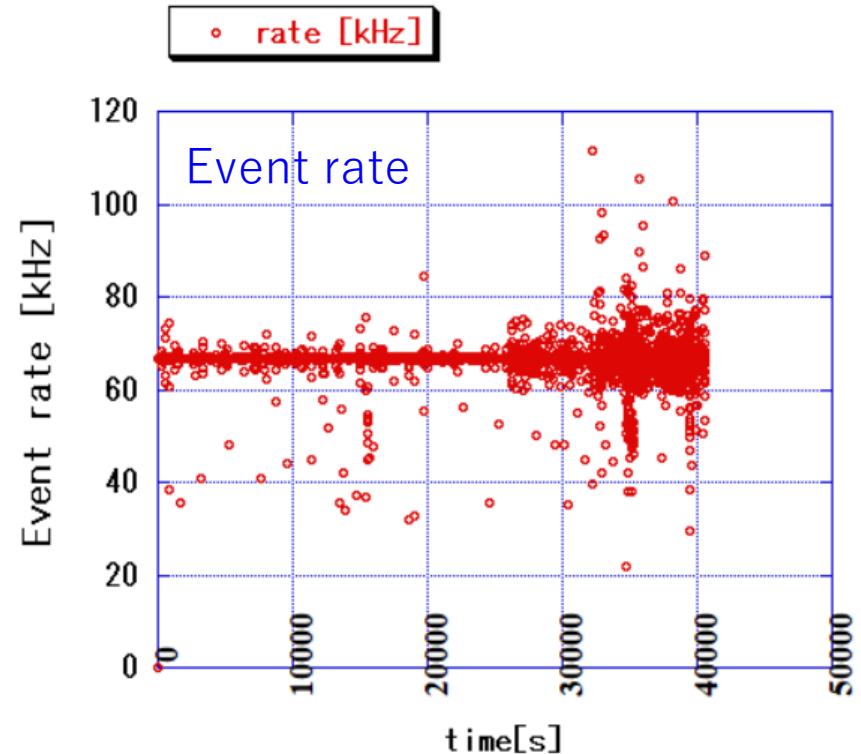
2-2. Stress test for CDC : input pseudo-Poisson 100kHz trigger

- CDC Suppressed data mode
- Trigger hold-off : 5trg/26us limitation
- Data are discarded at an HLT input server.

- 66kHz output is limited by 5trg/26us trigger hold-off
- This run(8/17 23:43) was stopped manually.
 - SSO bit error did not occur in this run after changing the HSLB firmware

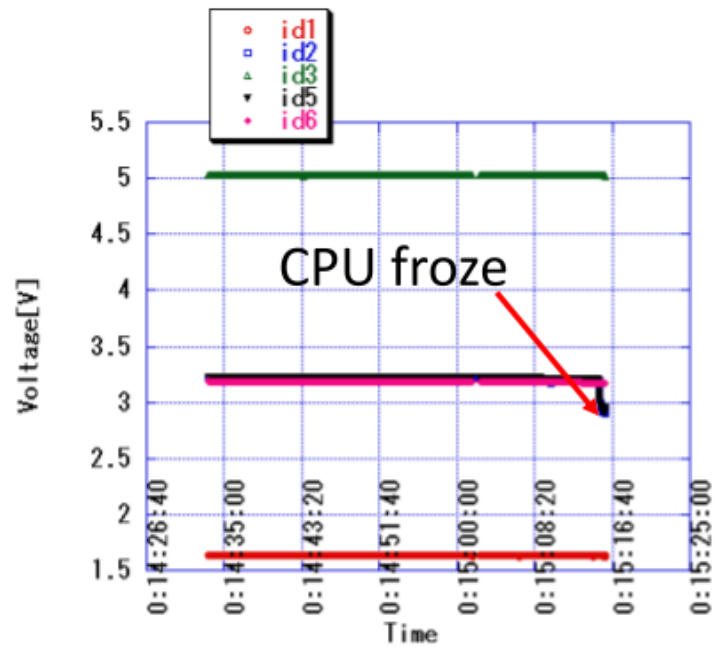
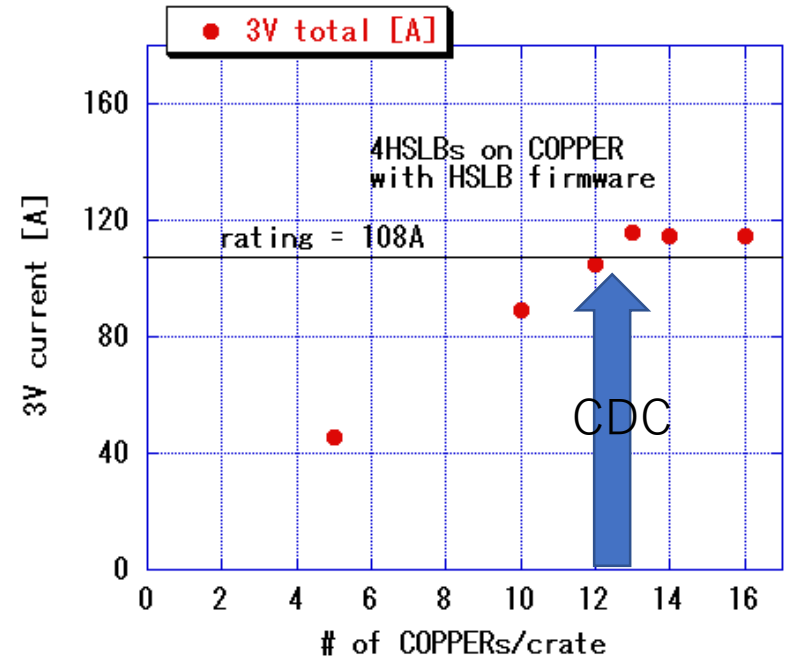
3V current usage of COPPER crate

Voltage drop problem in COPPER crate (reported at the Oct./Feb)

- COPPER onboard CPU sometime froze due to 3V voltage drop.
- 3V power supply of COPPER crates should be reinforced for six CDC crates, whose # of COPPERs per crate is larger than other sub-detectors.

-> Last JFY, we bought 3 out of 6. The reset 3 crates will arrive at KEK this month
of COPPER = 15, 4HSLBs/COPPER

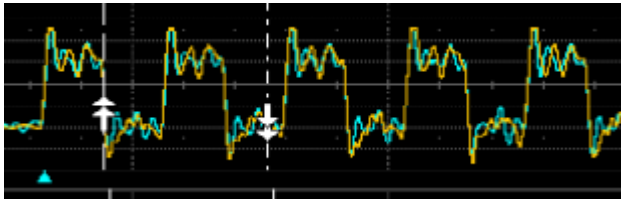
12mA

(Yellow: data signal at HSLB output pin
Blue : After a driver)

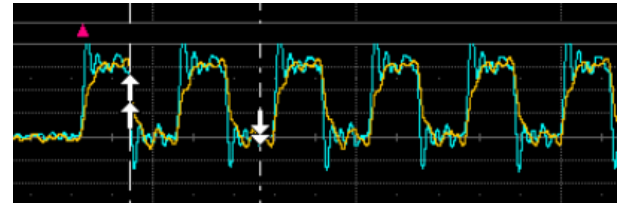
2mA

(Yellow: data signal at HSLB output pin
Blue : After a driver)

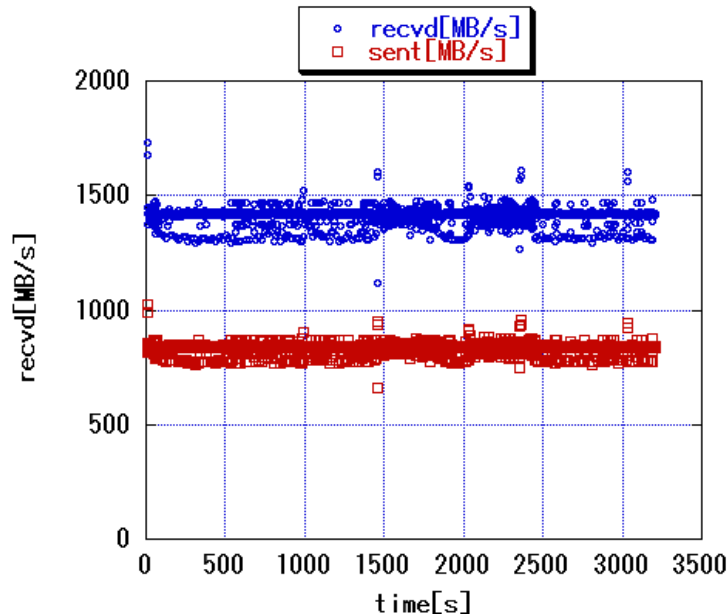
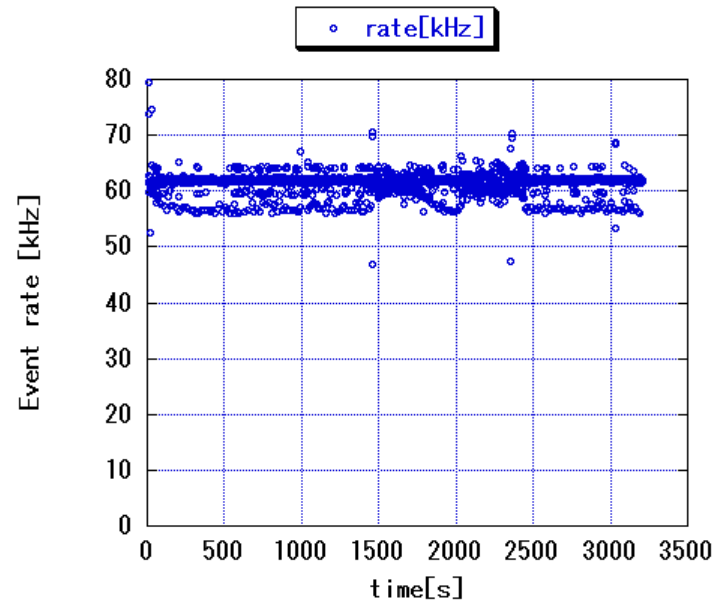
Recent stress test for CDC (After avoiding “ff00ff00” data corruption)

- 100kHz Pseudo Poisson input (5trg/26us limitation)
- CDC HV off : Almost no hits
- Data are discarded at hlt input server.
 - Nice nc processes were used to receive data from nine readout PC

- DAQ stopped after about 1hour running due to data corruption.
- Trailer value is corrupted : c4f0 -> c0f0 . Probably, SSO related corruption on CC

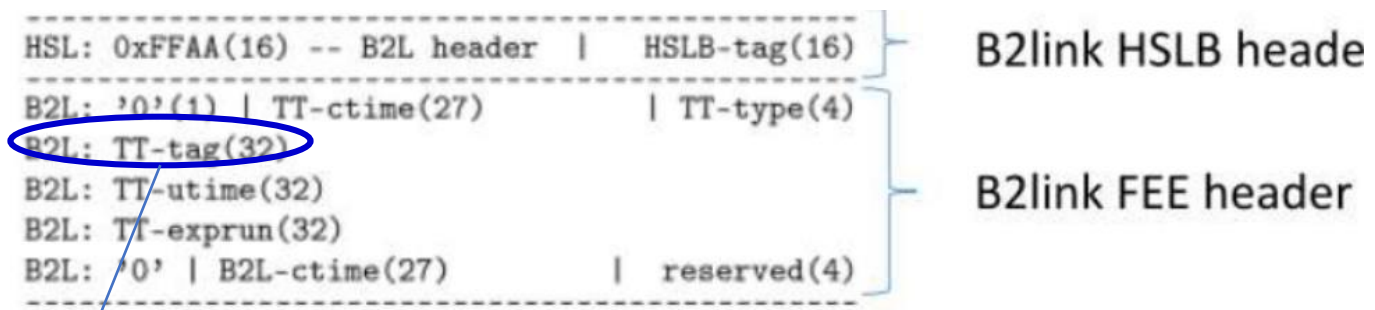
New type of Data Corruption in CDC COPPERs reported at prev. DAQ meeting -> seems to be fixed last Friday

[Header of event-fragment received by each HLSB]

Slot A: ffaa02a7 6e2202a7 **4c241bc9** 000002a7 490c6900 000241b0
 Slot B: ffaa02a7 6c261bc9 **000002a7** 592e697f 0008c100 6c262bd0
 Slot C: ffaa02a7 6c261bc9 **000002a7** 592e697f 0008c100 6c262cb0
 Slot D: ffaa02a7 6c261bc9 **000002a7** 592e697f 0008c100 6c262bb0

This error cannot be skipped because header is corrupted.
