Belle2link Update

Mikihiko Nakao (KEK)

2017.8.24

Trigger/DAQ workshop

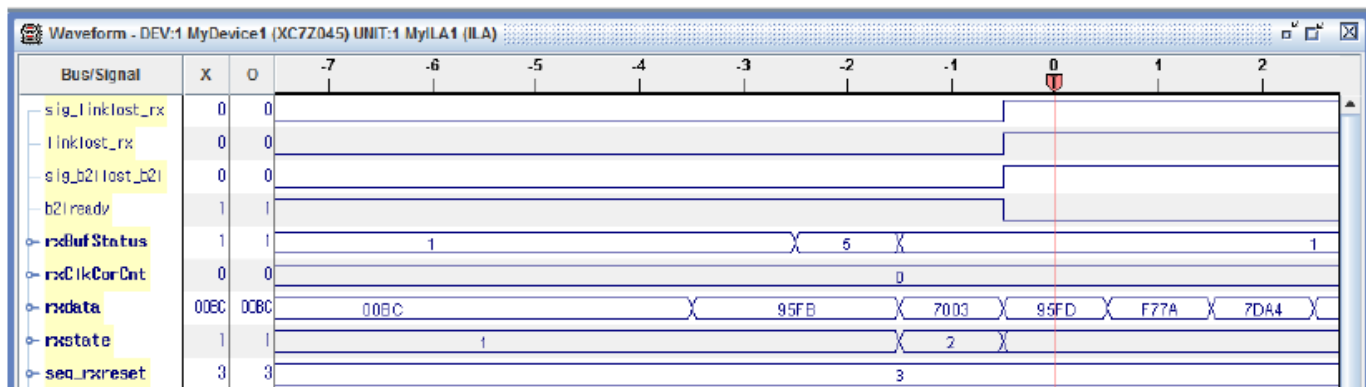
- x"95FB" of rxdata trigger comes twice
- State sequencer goes to 0 and is stopped because sequence for that is not set
- Our solution : Add new sequence that covers this situation
 - After adding, long time trigger test is finished successfully

Trigger shape when x"95FB" comes twice
