COPPER readout

S. Yamada (KEK, IPNS)

READOUT SUBSYSTEM IN BELLE II DAQ

1. Data corruption on HSLB/COPPER

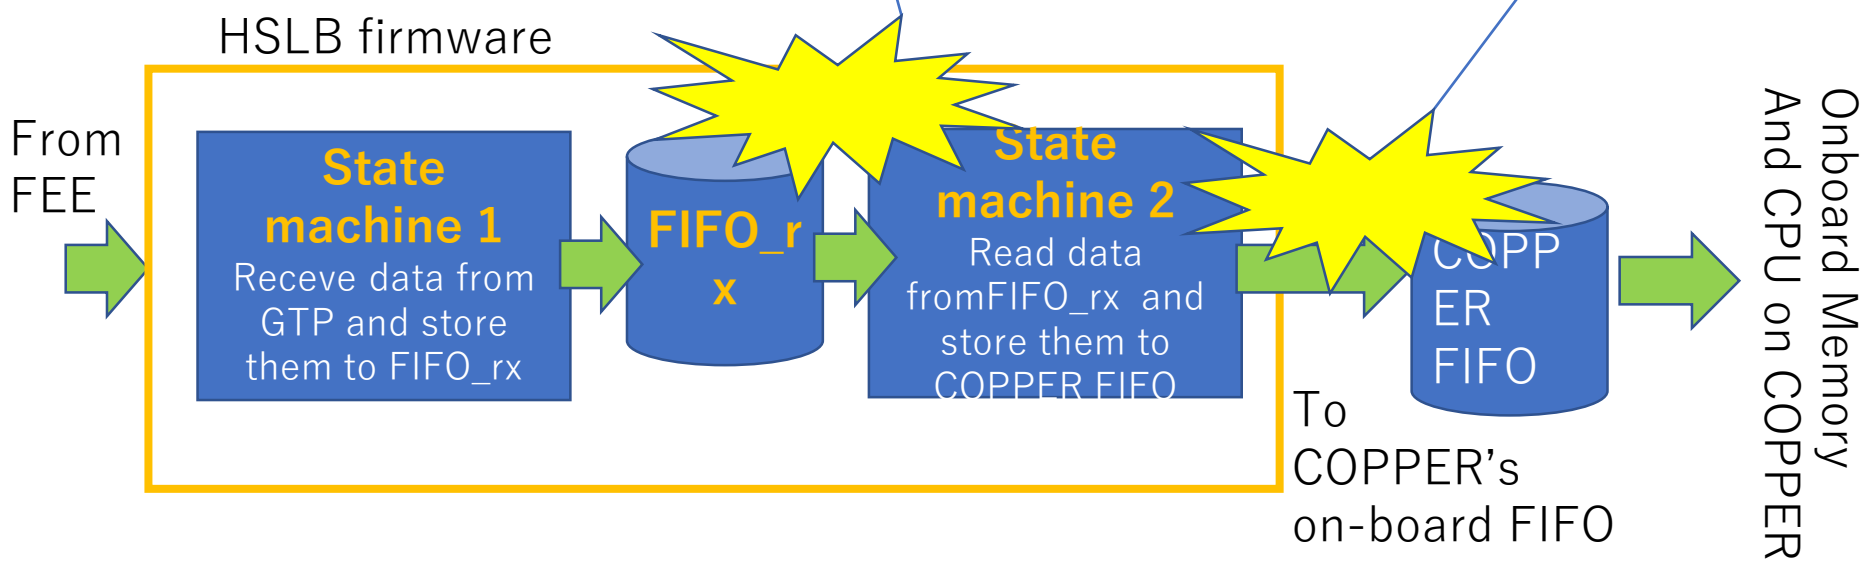
Two types of data corruption

A. Data are filled with strange patten such as "ff00ff00"

**B. SSO(simultaneous switching output) Error :
Some bits are corrupted
Feffffff 01000000
->feffffff 00000000**

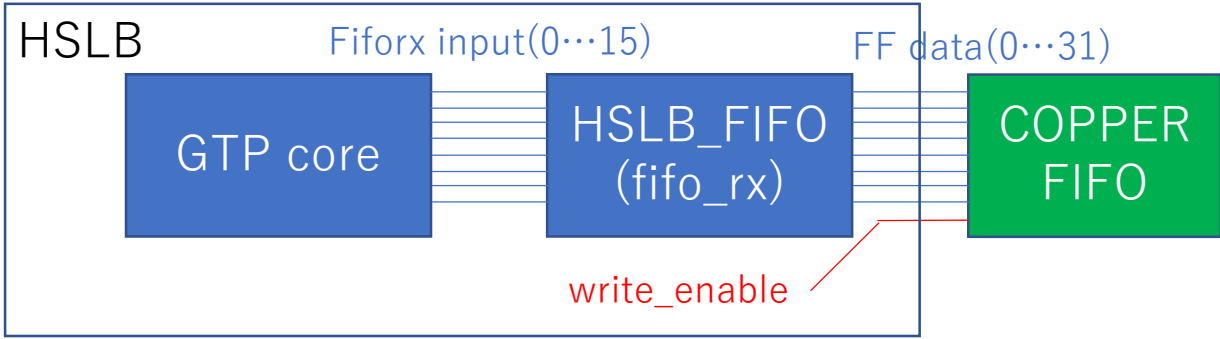
Data flow from HSLB to COPPER FIFO

FF data output and write enable

- So far, even when write_en = false, the output from HSLB (FF data) has some value.
- I changed the firmware to keep FF_data zero while write_en = false.

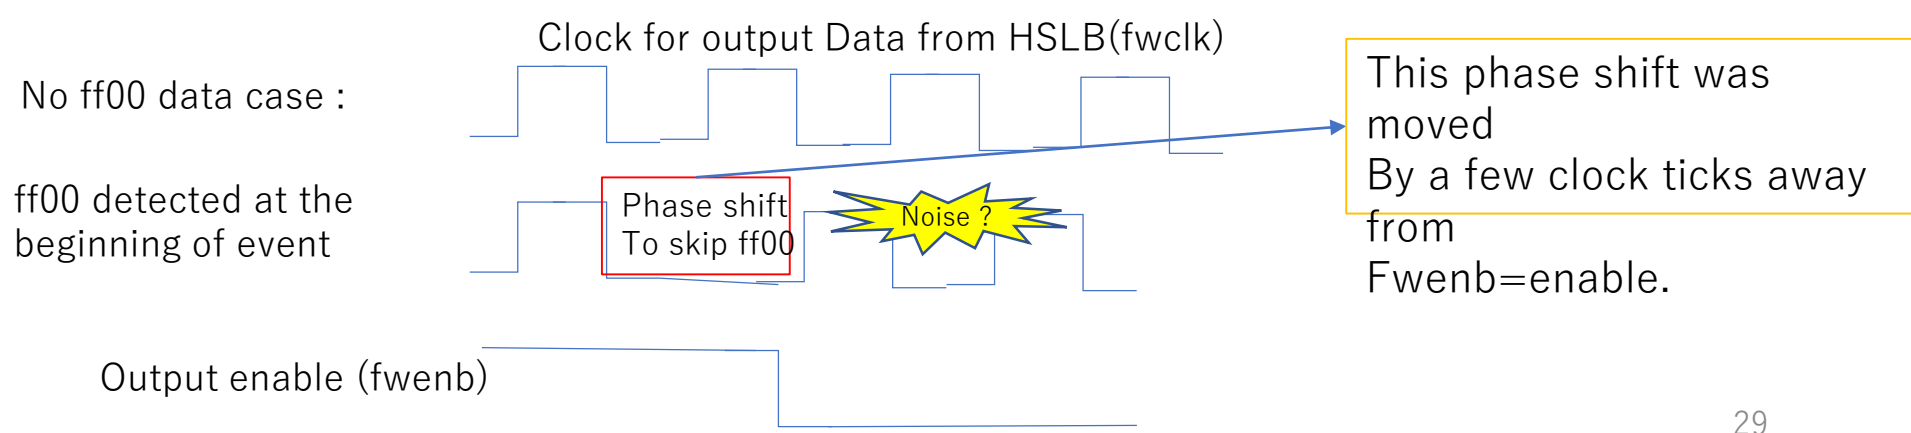
This error cannot be skipped because header is corrupted.

Workaroud to avoid ff00 data caused this new type of corruption
