Event Builder

S.Y.Suzuki, (KEK CRC)

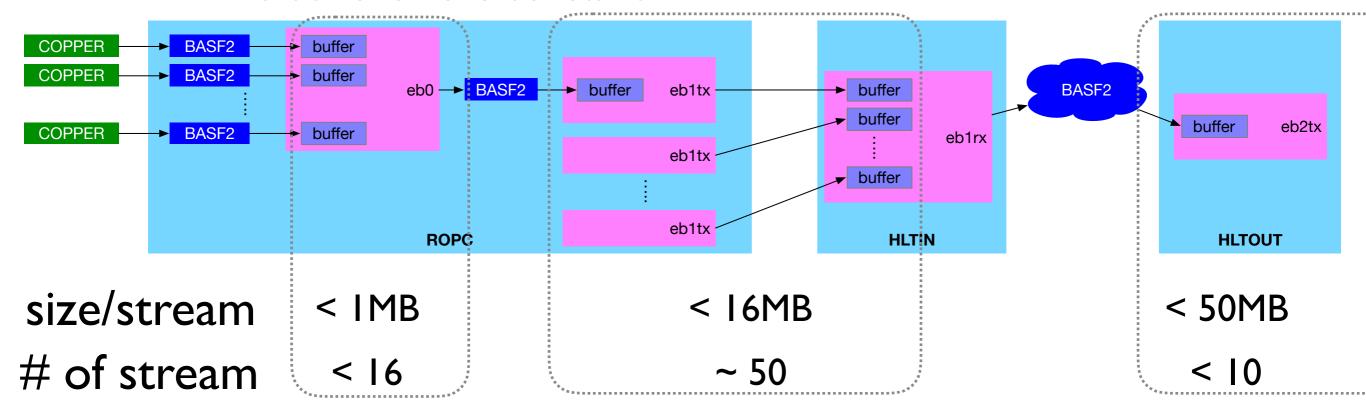
Problem

- eb0+1+2 use an identical class to receive data from network
- The buffer size is constant

• allocation 50MB x 16streams at ROPC results

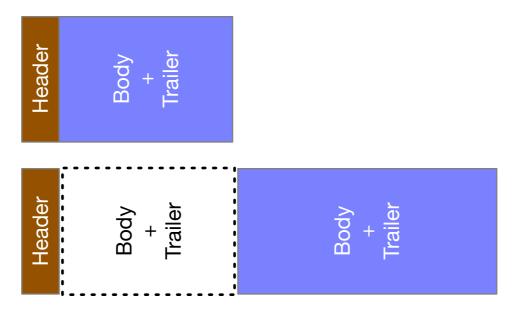
- Initially allocate short buffer
- extends it if event is longer
- Data corruption bug caused by non-contiguous buffer after the extension
- needs lots of fix about buffer management

gave up this way

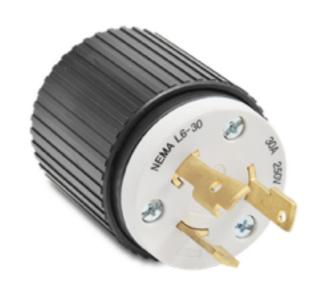
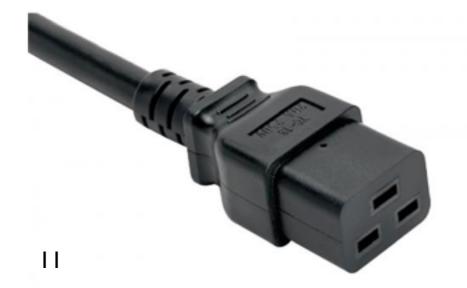
Partially installed, but

- No power outlet for ordinary 100V around optical patch panel to E.H.
- 1Φ 200V seems to be available, but we need more L6-30A - C19 cables
